# DETECTING AND PREVENTING DEFECTIVE JOINT FILLER INSTALLATION WORK

## Technical Bulletin 7

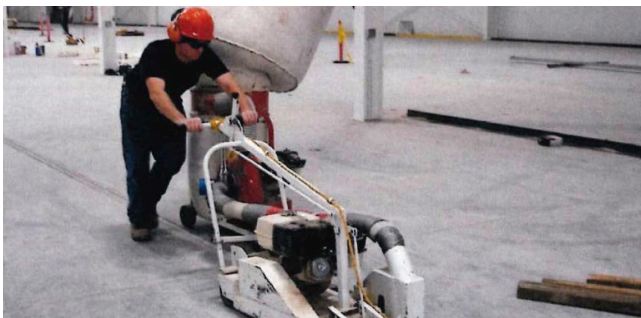
Above: Joints should be cleaned mechanically using a saw (preferably dustless) equipped with diamond or abrasive blade to expose clean, bare concrete along joint walls.

Fillers must bond directly to bare concrete if they are to maintain sufficient adhesion to be effective in providing proper load transfer and protecting joint edges. The only sure way to obtain clean joint walls is by dry saw-cutting, with the saw blade hitting both inner joint walls. Manual scraping of the joint with rakes or hand tools, or blowing out joints with compressed air is not adequate.

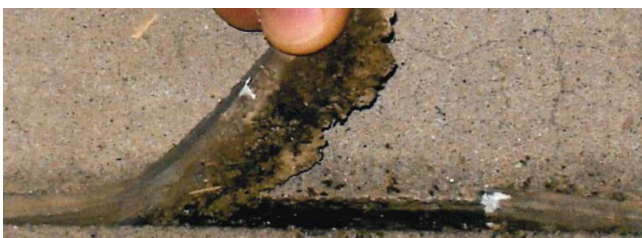
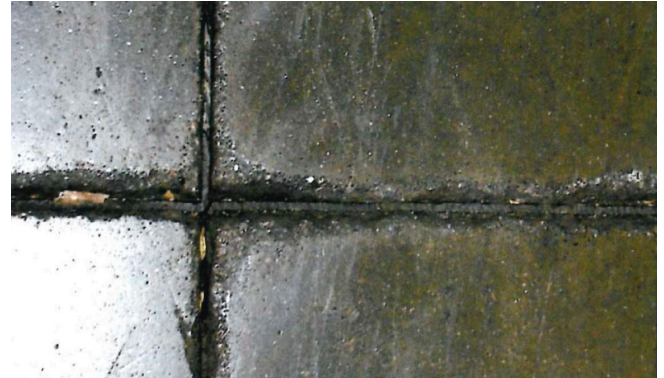
You can identify inadequate cleaning by extracting a cured sample of filler and determining if dirt/debris was embedded in the liquid filler before it cured.

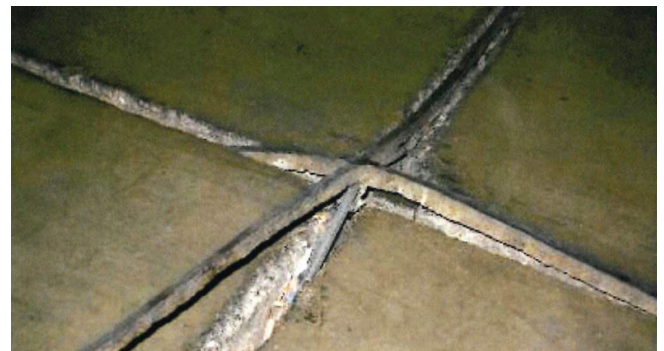
Above: Filler placed over a compressible foam backer rod to reduce material usage. Filler must be placed at full depth to provide joint edge protection.

To provide proper load support, fillers must be firmly seated on the bottom shelf of the joint. If fillers are placed over backer rod or debris, they can be sheared-off their bonding surface and driven down into the joint, leaving joint edges exposed. Both ACI and PCA mandate full depth filling in saw cuts 50mm or less in depth. When a filler drops below the surface, it is usually a sign of less-than full filler depth.

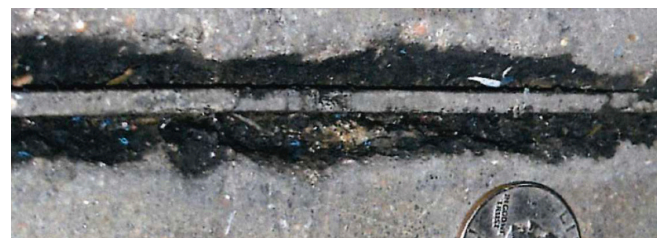
Below Shallow filler "punched down" into joint

To verify filler depth, simply use a 5mm bit and drill through the filler. If the bit has uniform resistance until it hits the joint base, it is likely installed full depth.

But, if the drill bit plunges through at any stage, or shows variances in resistance, shallow filling is probable and filler samples should be extracted from joint for examination.

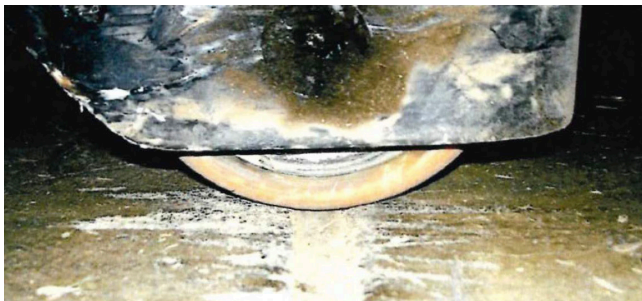
Above: The finished profile of a semi-rigid filler needs to be flush with the floor surface, if it is to provide joint edge protection. A concave or "dished" filler profile provides no joint edge protection, and leads to joint edge deterioration (spalling).

A properly installed filler will allow vehicles to cross the joint and exhibit no signs of impact. Fillers that cure in a concave profile allow impact, which will eventually lead to joint edge spalling. The only means of ensuring a flush filler profile, is to overfill the joint, allow the filler to cure into a solid, then razor off the overfill. The best way to determine an acceptable flushness level, is to run a vehicle across the joint and determine if impact is detected. An alternate method, is to run a straight edge across the joint and look for any void below the straight edge.

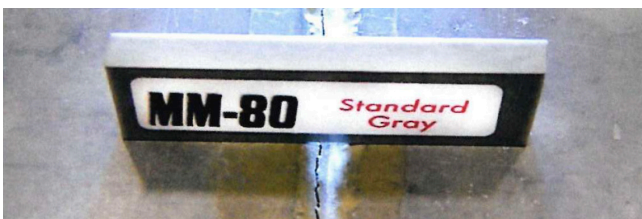
Below: Straight edge reveals void between floor surface and filler profile across the joint.
