JOINT FILLER

Technical Bulletin 5

FLUSH FILLER PROFILE IS CRITICAL

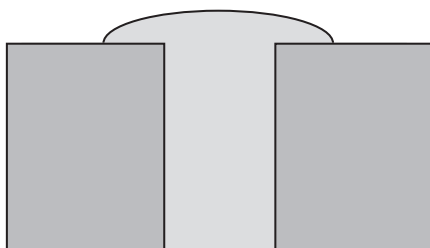
FILLER CROWN

The only method of preventing concave filler profiles is called the overfill-and-shave procedure. When filing, the installer dispenses enough material so that a filler crown is created. This crown is left in place until the filler cures into a solid. At this point the installer shaves off the crown, leaving the final filler profile flush with the floor surface.
