THE FIRST YEAR IN THE LIFE OF YOUR NEW FLOOR

JOINT FILLER

Technical Bulletin 4

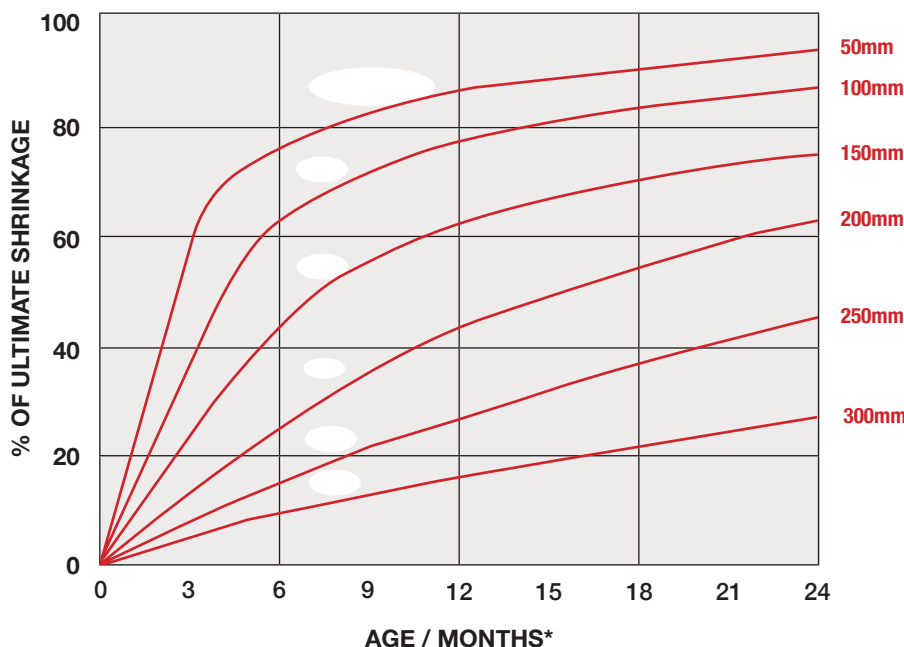
CONCRETE SLAB SHRINKAGE RATE

One Portland Cement Association (PCA) study indicates that a 150mm slab-on-grade has a typical shrinkage rate of:

First 30 Days	15%
Next 335 Days	50%
Total, One Year	65%

*Drying in Laboratory Air From PCA Dev. Dept. Bulletin 103

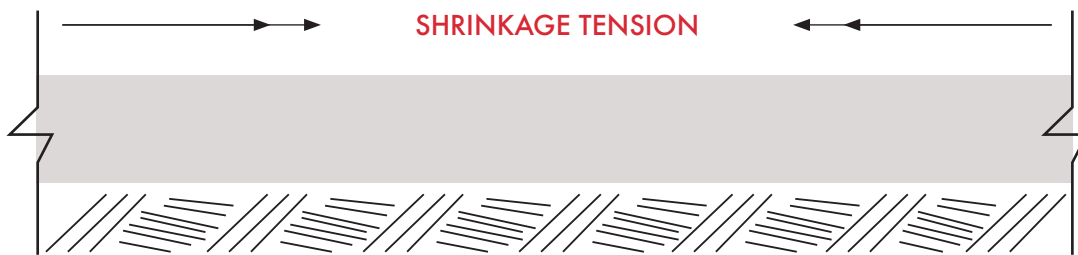
Imagine taking a section through your floor slab. Since the top of the slab is exposed to the air, allowing moisture to evaporate, it can dry fairly rapidly. As it dries out, tension is created on the surface. The bottom is also shrinking, but at a slower rate, creating additional tension and can cause cracking of the slab.
